Reconnaissance report of the M6.9 Sikkim (India–Nepal border) Earthquake of 18 September 2011

The M6.9 Sikkim Earthquake of 18 September 2011 caused widespread devastation in the state and adjoining areas from disrupting the road network to damaging structures of commercial, public, and religious values. This event presented another opportunity to further the understanding of earthquake risk of the affected region as well as of the North-Eastern Himalayan region, which have similar patterns of seismicity, built environment and construction practices. The general pattern of damage to structures, landslides, rockfalls, etc. was consistent with the shaking associated with this event. However, collapses of many buildings and damages to structures were disproportionate to the observed intensity of shaking, primarily due to poor compliance with seismic codes, inferior quality of raw materials and shoddy workmanship. Consequently, the seismic risk in the region is growing at an alarming pace with increasing inventory of vulnerable construction. The current event provides a preview of what is likely to happen in the event of a larger earthquake which the Himalayan region has witnessed in

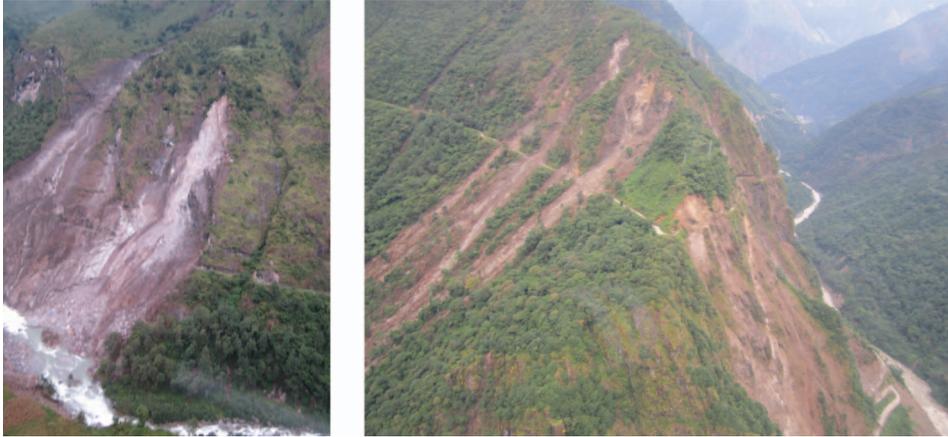
The earthquake caused more than 300 landslides spreading over approximately 2400 sq. km area from Namchi in the South District to Lachen in the North District of Sikkim state. A large number of landslides were observed at higher altitudes close to the epicentral region (figure 2). Landslides cut off the severely affected areas such as Chungthang and Lachung from the rest and hampered rescue and relief operations. In Lachung, rockslides and mudslides after two days of the main event changed the course of a stream and caused extensive damage as shown in figure 3. Several areas of these cities are prone to ground sinking and have unstable slopes which become more susceptible to failure in the rainfall.

Figure 2. Aerial photograph showing typical landslides en route from Mangan to Chungthang and Lachung.

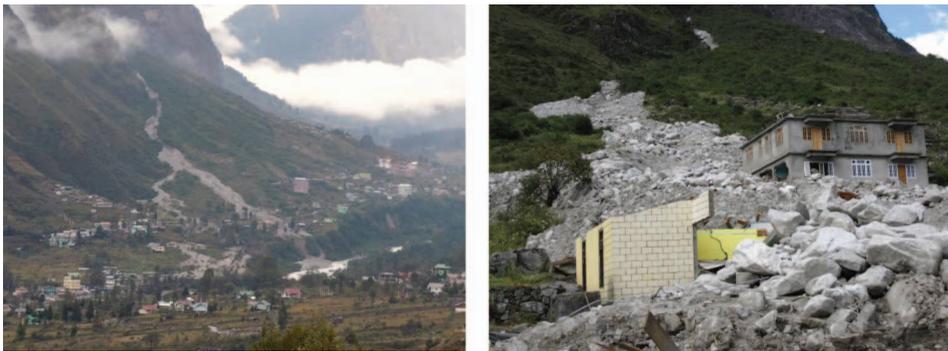
Figure 3. Damage caused due to rockslide and mudslide at Lachung (*MSK-VIII*).

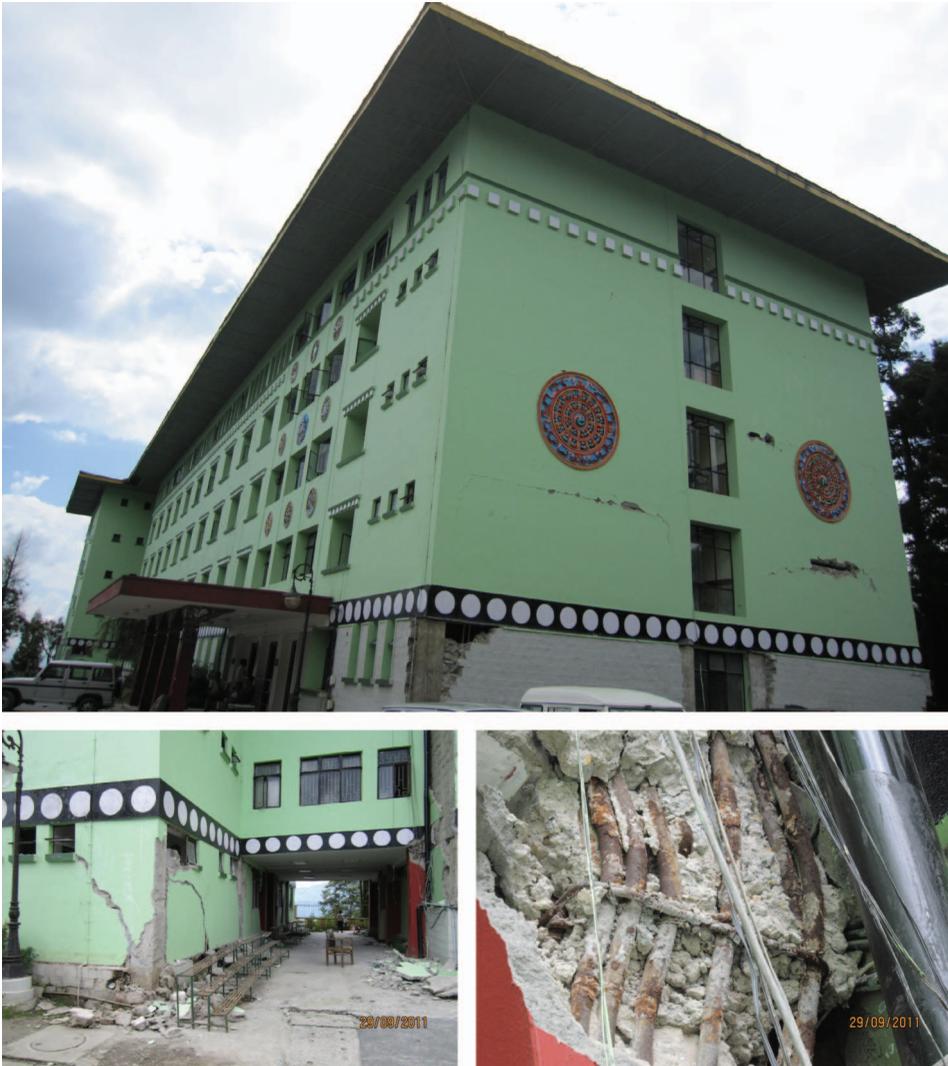
General damage to buildings and other structures agreed well with the intensity of ground shaking observed at various places, with the maximum of VIII at Chungthang and Lachung, and VI in and around Gangtok and Mangan on MSK scale. However, unexpected severe damage at an intensity of VI in Gangtok was observed in buildings such as the secretariat building at Tashiling in Gangtok (figure 4). It was a 32-year-old RC frame building infilled with hollow concrete

block. This building suffered damages in columns, infill panel, cladding, etc. Minor damage was also observed in this building during the 2006 Sikkim Earthquake (Mw 5.3). In addition, partial collapse of two multi-story buildings at Balwakhani (figure 5*a* and *b*) and total collapse of a five-storey building at Lumshey Basti (figure 5*c* and *d*) were observed.

Figure 4. Damage to the state secretariat building at Tashiling in Gangtok (*MSK-VI*).

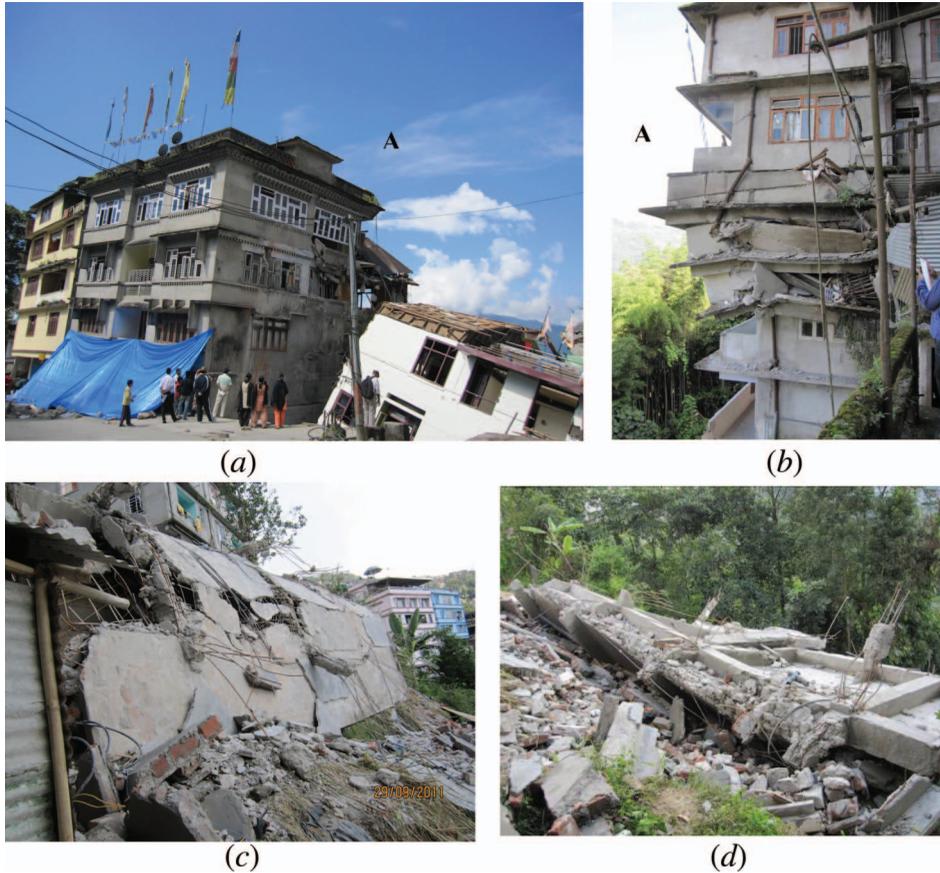
Figure 5. (a) Collapse of two multi-storey buildings at Balwakhani in Gangtok (*MSK-VI*); (b) view of building A, in figure 5a, from backside; (c) and (d) collapse of a five-storey building at Lumshey Basti in Gangtok.

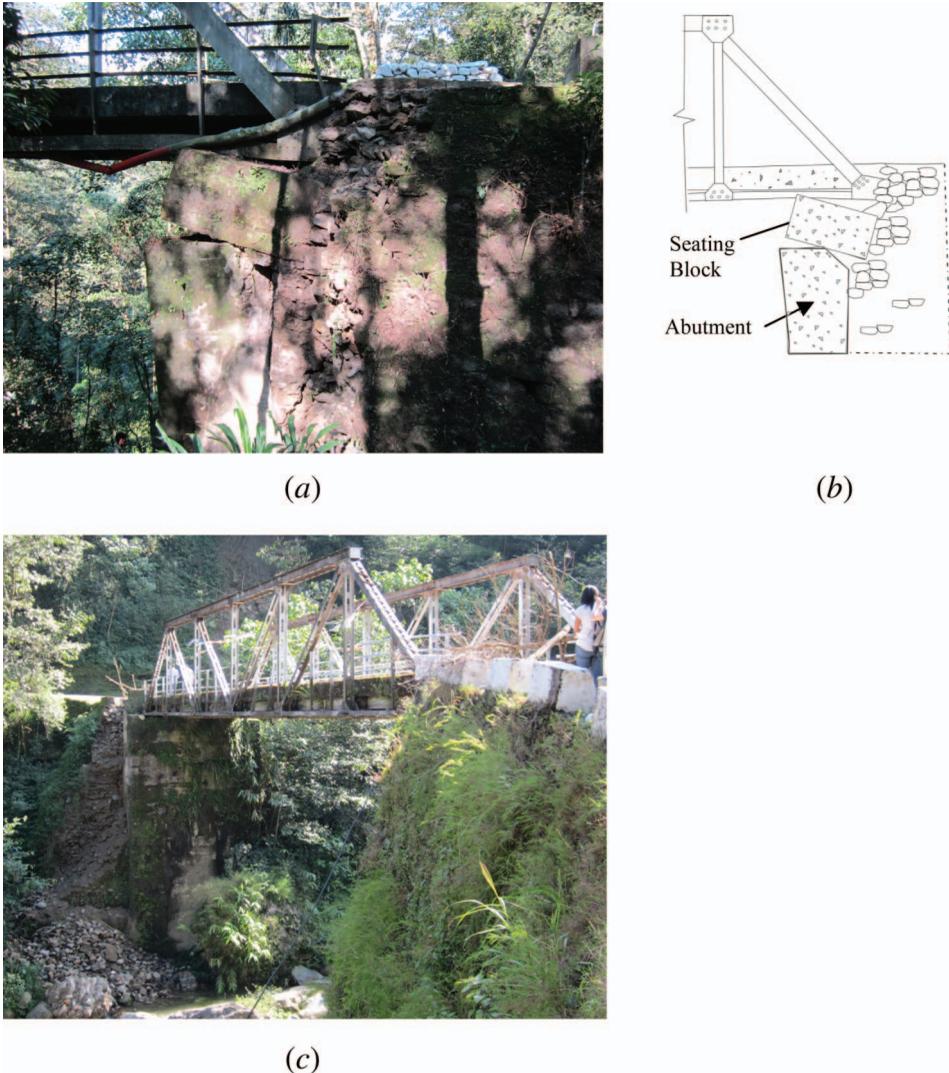
Apart from the buildings, the area has a large number of highway and pedestrian bridges on rivers, rivulets and gorges. Only minor damage to a few highway bridges was noticed in the areas visited (figure 6). Abutment of the Palekhola Bridge (*khola* means river) sustained minor damage mainly due to the inadequate support of the seating block which rotated towards the backfill after the partial loss of bearing during the earthquake shaking (figure 6*a* and *b*). Partial collapse of wing walls of the Raykhola Bridge (span 32 m) was observed on both sides (figure 6*c*). Damage to the wing walls was caused by the low strength random rubble (R/R) masonry, poor workmanship and construction. However, the main steel truss bridge performed satisfactorily during this earthquake.

Figure 6. (a) Failure of seating block overhanging the abutment of Plaekhola Bridge, (b) schematic of the failure of seating block at Plaekhola Bridge and (c) damage to the wing wall of steel truss bridge on Raykhola.

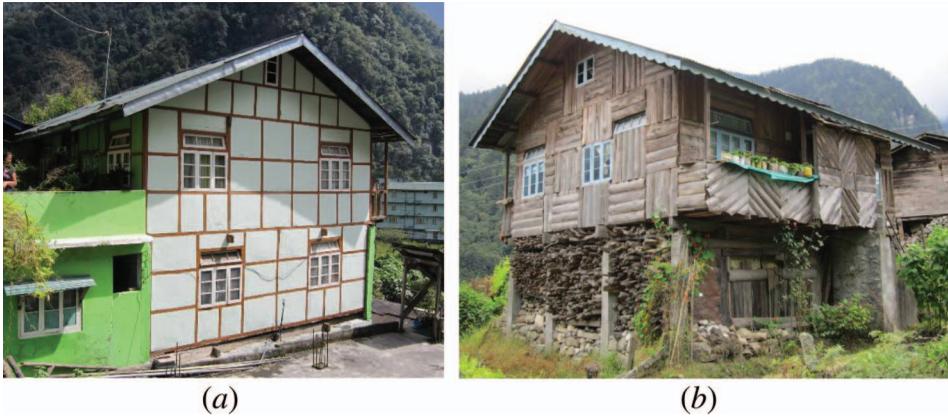
(figure 7) (Kaushik *et al.* 2006). These practices had been observed throughout the affected area and were more in number in the upper reaches like Lachung. *Shee-Khim* houses are single storey structures consisting of wooden frames and planks. However, *Ikra* houses are one–two storey timber framed structure filled with specially prepared infills made of bamboo splints and plastered with cement/mud mortar. In the present earthquake, no major damage was observed and reported in such houses. Presence of wooden frame at close intervals resulted in an excellent earthquake-resistant feature that performed well.

Figure 7. Traditional construction type: (a) *Ikra* house and (b) *Shee-Khim* house.

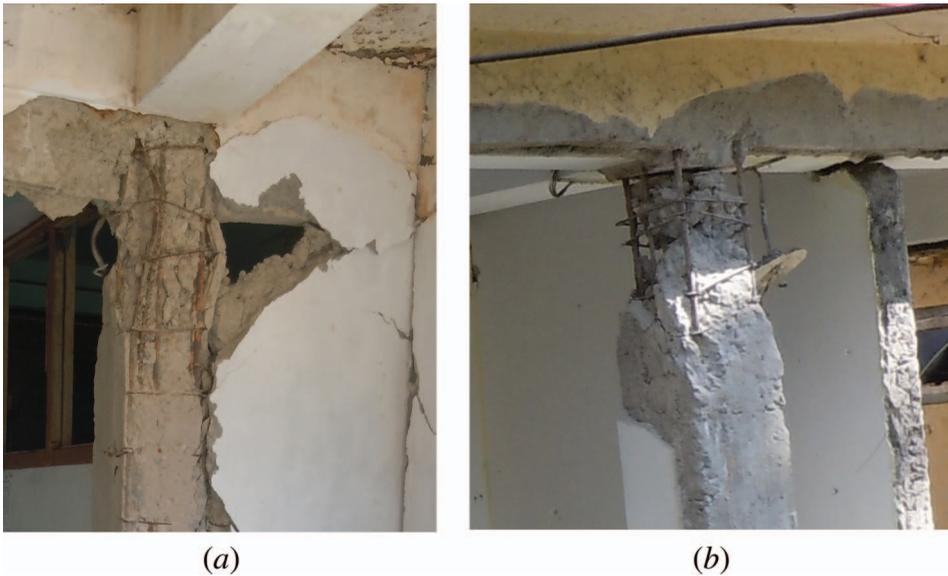
Unlike traditional houses, many government and private RC buildings sustained severe damage and even collapsed due to lack of earthquake-resistant features, such as ductile detailing in RC beams and columns (adequate confining reinforcement and stirrups with sufficient hook length bent at 135°), proper splicing of bars, and lapping of reinforcement away from beam–column joint, etc. Many unique and inherently poor construction features, such as weak and very slender partition walls in brick/block masonry or in lightly reinforced/plain concrete, extended floor plans in upper stories supported on cantilevered beams and slabs, construction on sloped ground,

unstable slopes, weak retaining walls, poor construction material, etc. significantly added to the seismic vulnerability of these structures. Most of the RC buildings at Gangtok and Chungthang suffered damages of some form or the other, the most common being shear and/or flexure failure at column ends, shear failure of beam–column joints, in-plane failure of weak infills and out-of-plane failure of slender walls (figures 8 and 9). In addition, buildings are constructed too close to each other, sometimes with no gap at all between adjacent buildings and this resulted in damage due to pounding of buildings (figure 10).

Figure 8. (a) and (b) Typical failure at column ends (widely spaced stirrups with 90° hooks, cold junction at the column top, poor concrete quality).

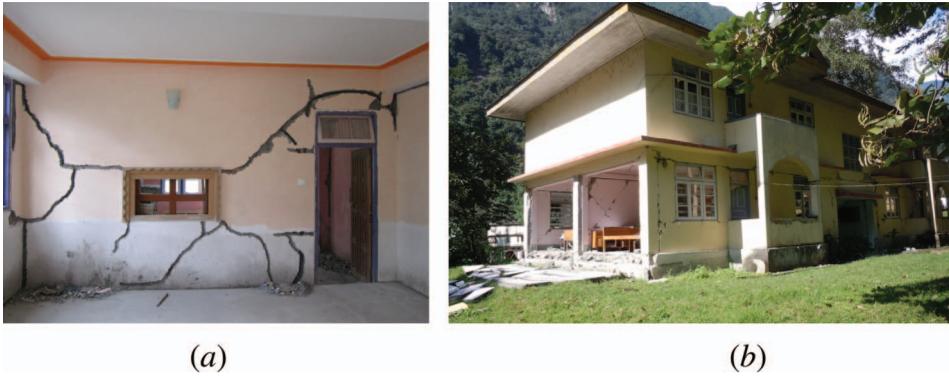
Figure 9. (a) In-plane failure of weak infill masonry and (b) out-of-plane collapse of concrete block masonry walls.

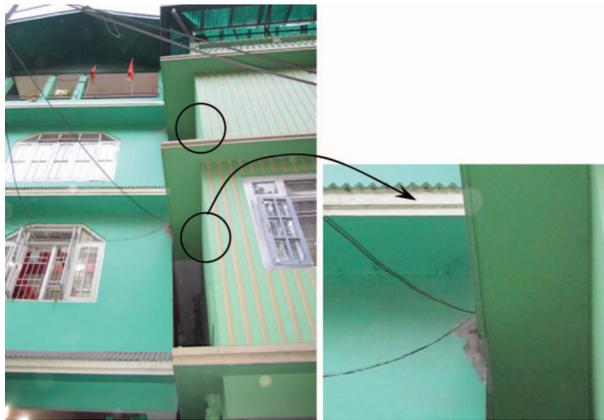
Figure 10. Pounding damage to adjacent buildings at Gangtok (*MSK-VI*).

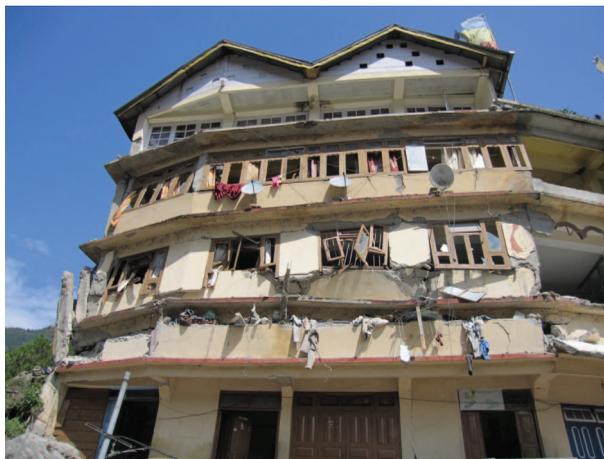
pancake collapse was observed in the third storey of a five-storey RC school-cum-residential building (figure 11). Well-built school buildings such as Tashi Namgyal Academy (TNA) in Gangtok performed satisfactorily as compared to the buildings deficient in earthquake-resistant designing and built during the colonial period in Kalimpong, West Bengal (figure 12).

Figure 11. Five-storey school cum residential building in Chungtang (*MSK-VIII*).

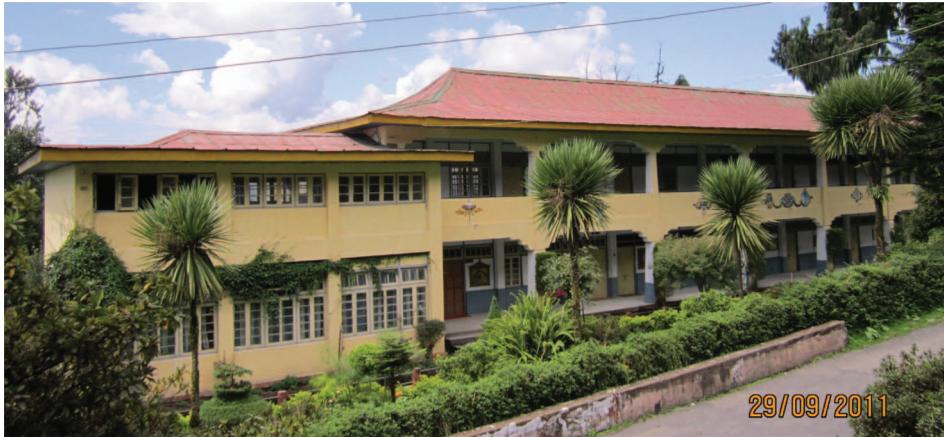
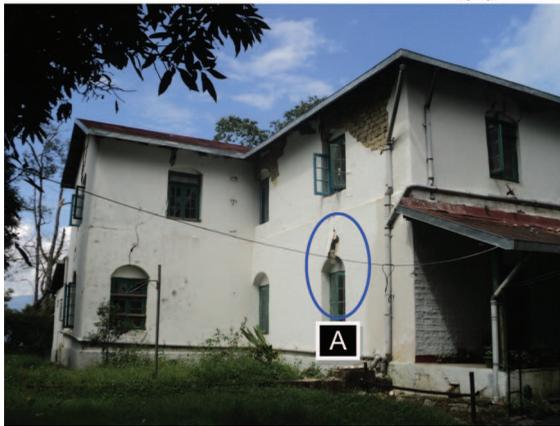
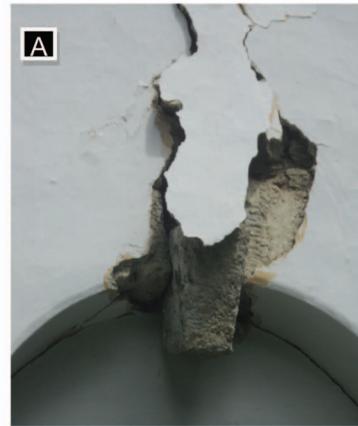
Figure 12. (a) Well-built school building of Tashi Namgyal Academy (TNA) in Gangtok (*MSK-VI*) performed well in the recent M6.9 event and (b) dormitory in Dr. Graham's Homes suffered extensive damage in gable wall and arch in building with re-entrant corner, Kalimpong (*MSK-V*).

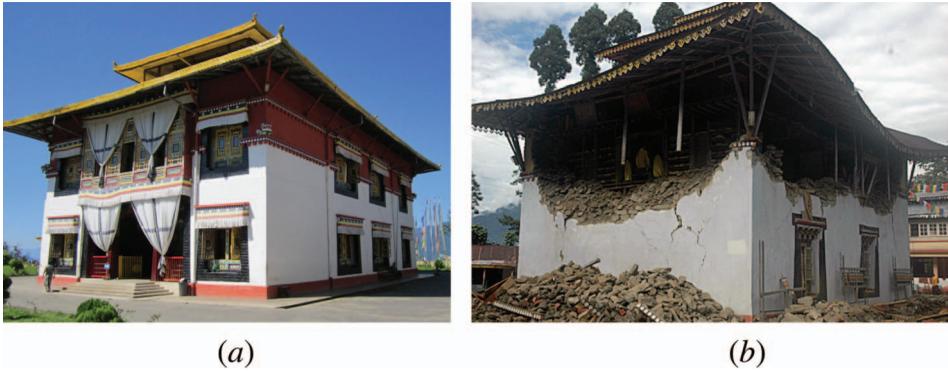
observed to exterior walls at several monastery temples at Mangan and Lachung (figure 13). In Kalimpong, two brick spires of the historic Mac Farlene Church have collapsed and the tall load bearing walls at the gable end of the building have numerous cracks (figure 14).

Figure 13. (a) Satisfactory performance of King's monastery in Gangtok (MSK-VI) and (b) partial collapse of Ringhem Choling Monastery at Mangan (MSK-VI).

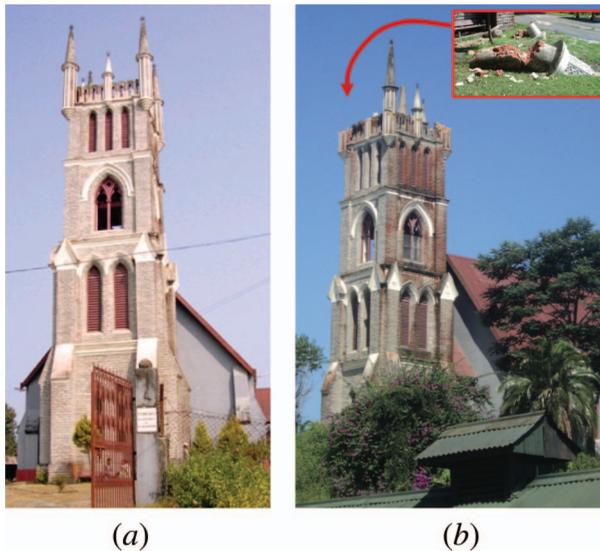
Figure 14. Collapse of brick spires of Mac Farlane Church at Kalimpong (MSK-VI): (a) before the earthquake (Photo: <http://mntravelog.com/tag/macfarlane-memorial-church/>) and (b) after the earthquake.
